ALCOA DAM  
NDI No. Pa. - 493

PHASE I INSPECTION REPORT

Alcoa Dam, DNI Number PA-493. Ohio River  
Basin, Little Chartiers Creek, Washington  
County, Pennsylvania. Phase I Inspection  
Report.

PHASE I INSPECTION REPORT  
NATIONAL DAM INSPECTION PROGRAM  
ALCOA DAM  
NDI# PA-493, PENNDER# 63-53

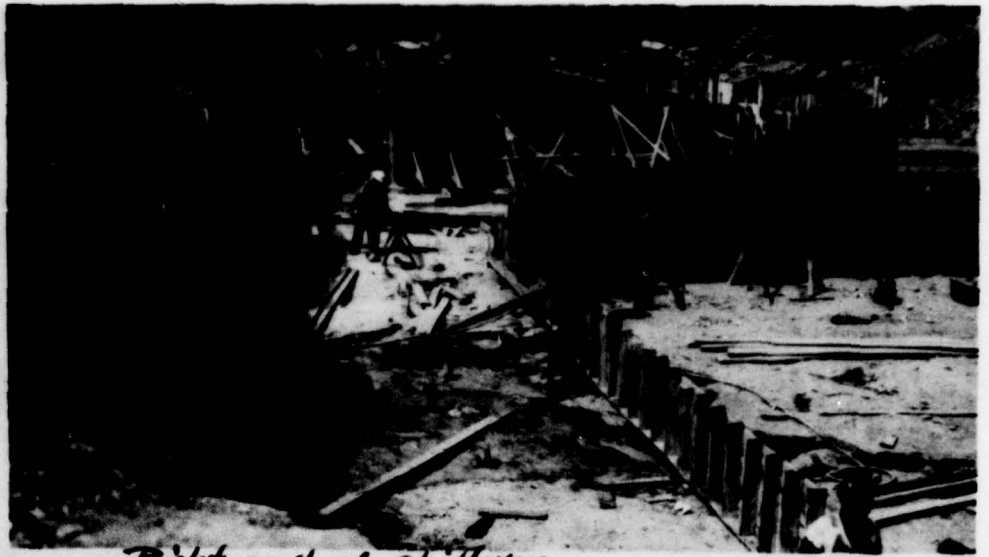
PHOTOGRAPH 1 View looking toward the left abutment from the right end of the spillway as it appeared in August 1943. Note the grout pipes along the centerline of the foundation

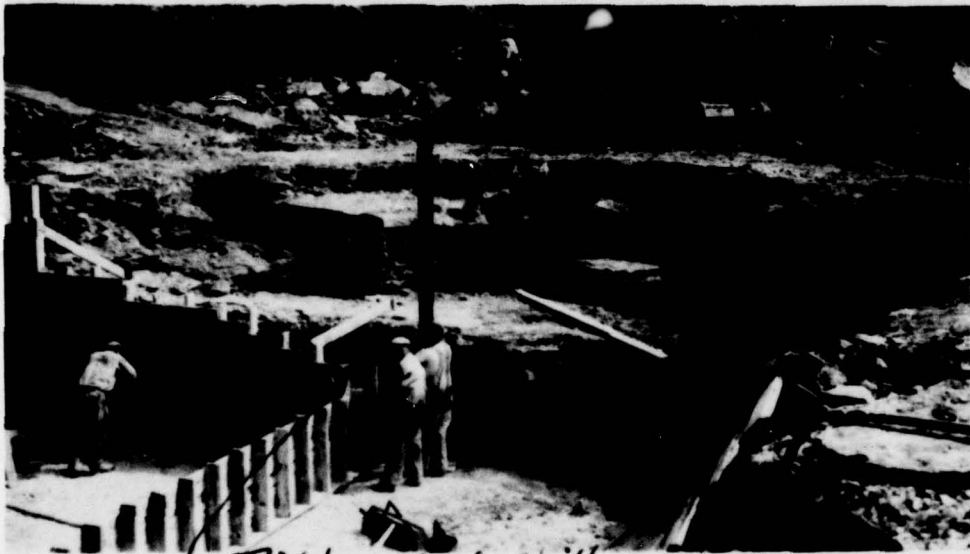
PHOTOGRAPH 2 View looking toward the right abutment showing the right end of the spillway.

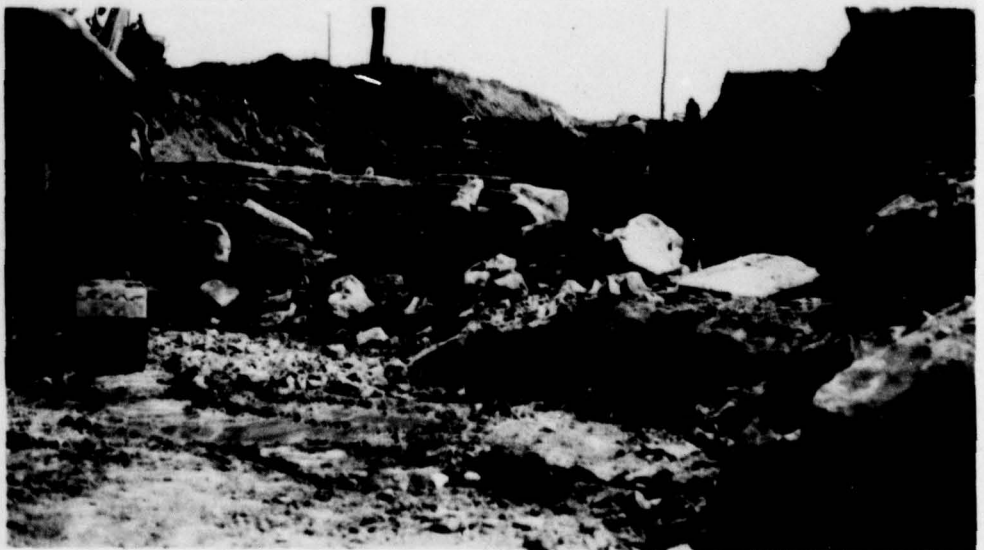
Most of the construction joints have been caulked with bitumen particularly those that exhibited evidence of prior efflorescence. An exception to this was the area to the left of the spillway where numerous cracks and some spalling were observed on the left abutment walls and in the side walls of the plunge pool (see Photograph 3).

PHOTOGRAPH 3 View looking along the centerline of the dam toward the right abutment as it appeared in 1943.

c. Remedial measures should be implemented to seal all cracks and restore any areas where the concrete has deteriorated. Special emphasis should be given to the area at the left abutment where cracking and spalling has apparently gone on unchecked because of difficult access. Debris and soil which has accumulated on the concrete surfaces in that area should also be removed.

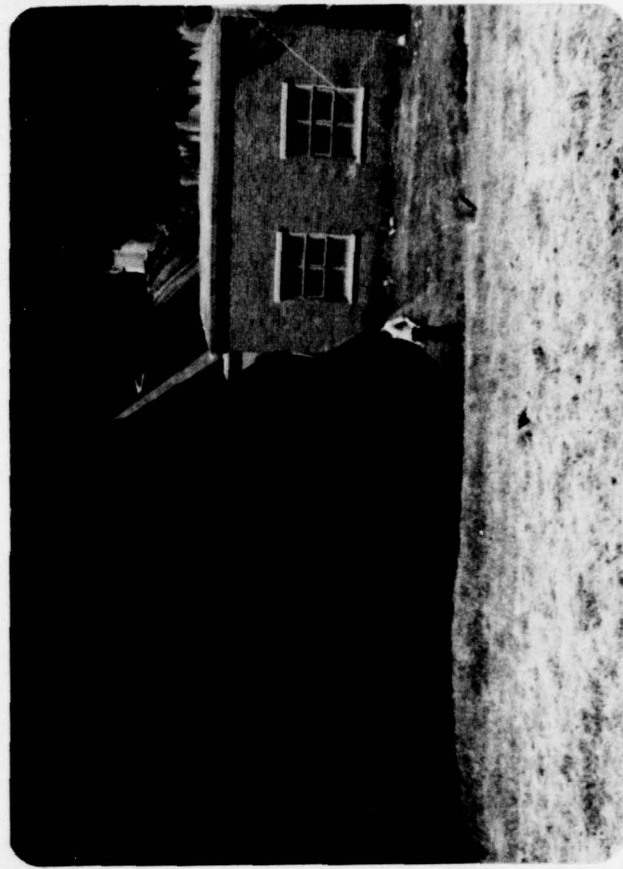
A small amount of water was observed to be seeping through a horizontal construction joint just east of the pump house. The ground in this area was saturated indicating that some seepage may also be passing through the dam foundation.

- PHOTOGRAPH 6 Close-up view of the Alcoa Dam spillway showing the debris which has accumulated at the approach to the ogee spillway.
- PHOTOGRAPH 7 View of an area of seepage (shown by the heavily vegetated area) near the right center portion of the structure. At the time of inspection it appeared that most of the seepage was issuing from beneath the structure and not through the construction joints as might be inferred from the efflorescence shown near the center of the photograph. The brick structure to the right is a pumphouse.

Overturning does not appear to be a problem under PMF conditions, however, resistance to sliding appears inadequate but cannot be sufficiently evaluated with available data. In addition, some seepage was observed at the base of the structure at a distance between 50 and 75 feet from the spillway along the right abutment. Consequently, additional seepage and stability studies are recommended.

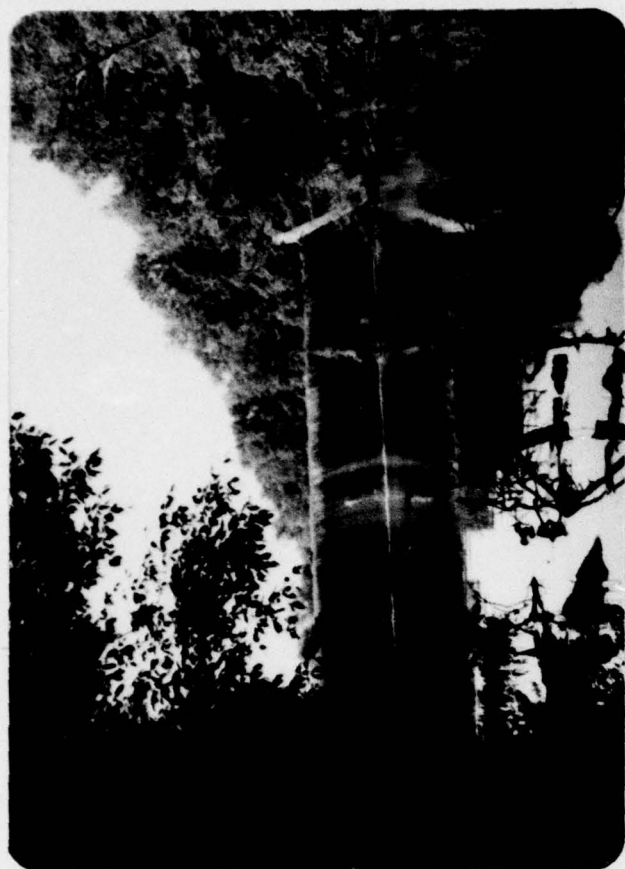
PHOTOGRAPH 9 View of the Alcoa Dam spillway and the channel just downstream of the dam.
